# REPORT

**Sterling PBES Energy Solutions Ltd.**

Date: May 26, 2021  
Report No.: 40.00.20479-1  
Revision No.: 0  
Project No.: 20479  
Equipment: Battery  
Model No.: BBU

### Fire Survivability Testing

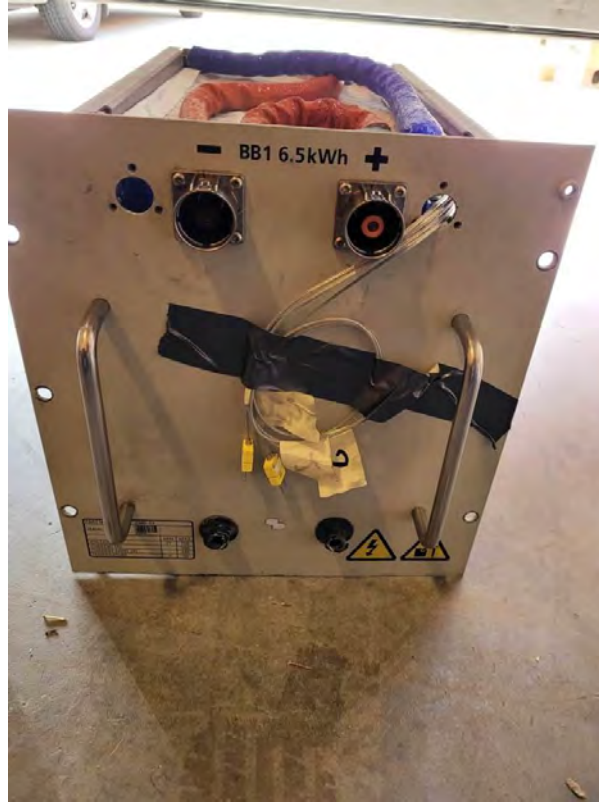
**Picture 1 – Unit BBU – Front View**

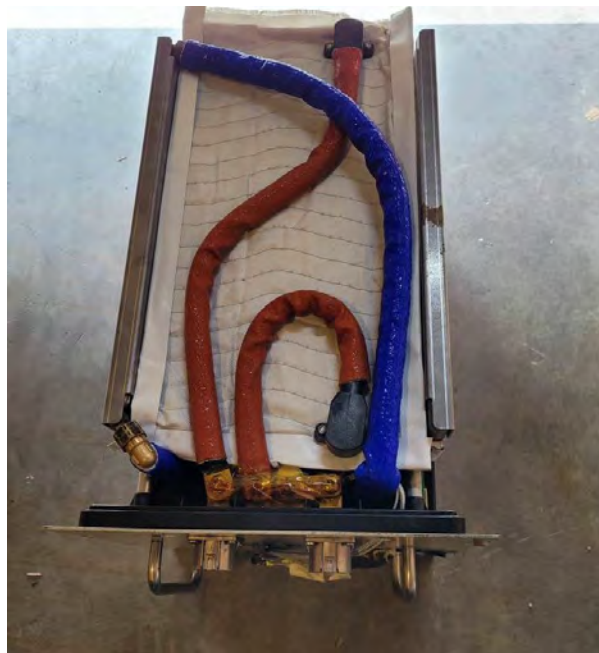
**Picture 2 – Units BBU – Top View**

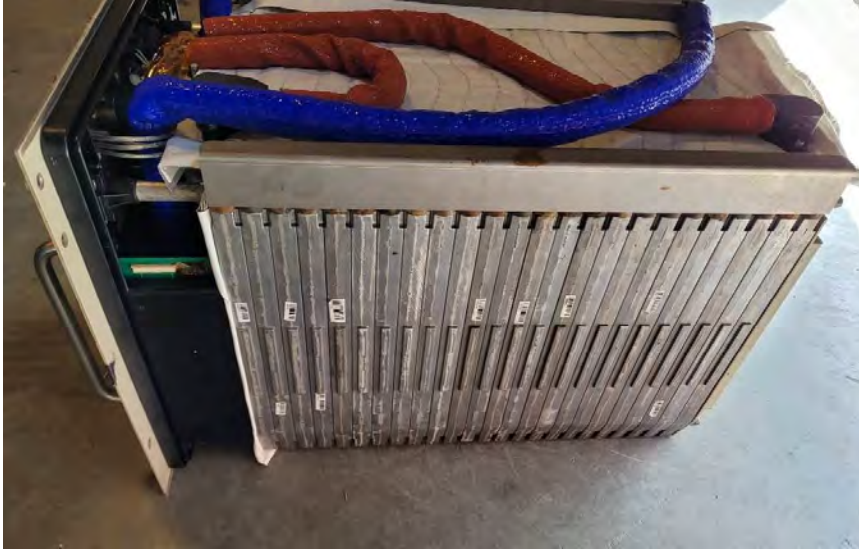
**Picture 3 – Unit BBU – Side View**

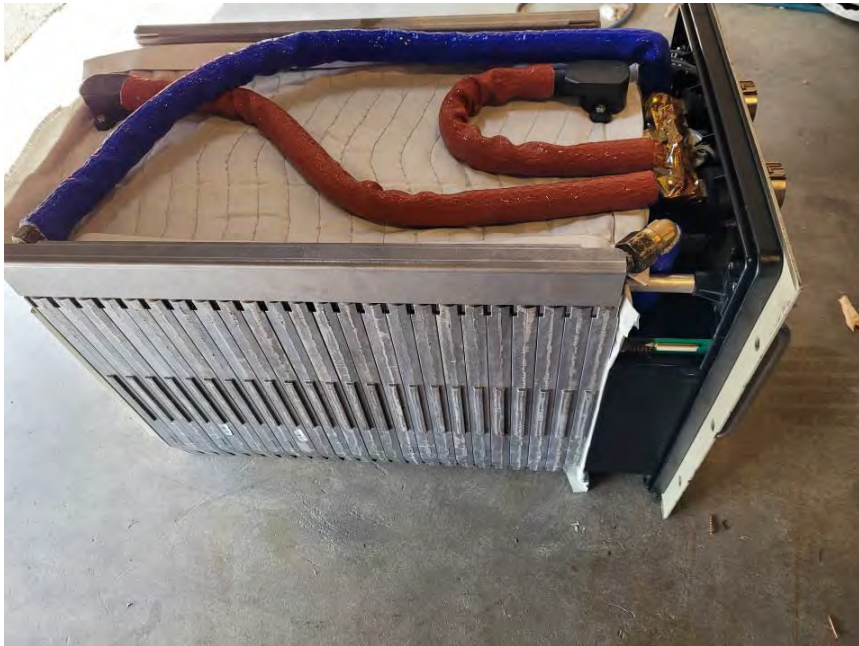
**Picture 4 – Unit BBU – Side View**

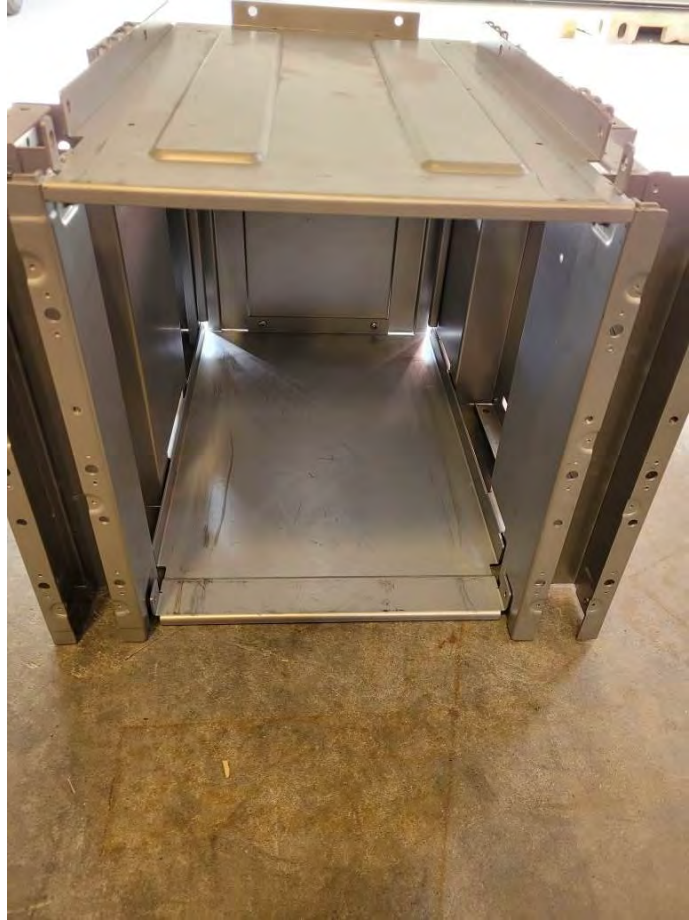
**Picture 5 – Unit BBU – Rack Internal View**

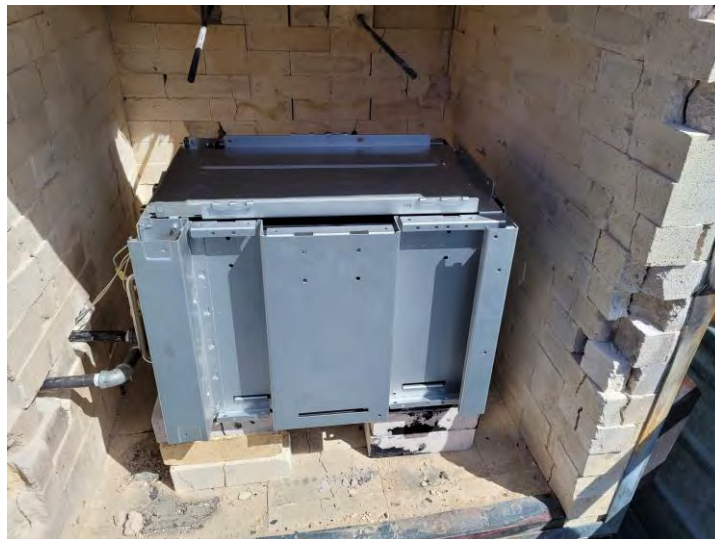
**Picture 6 – Unit BBU – Unit Installed in the Test Chamber**

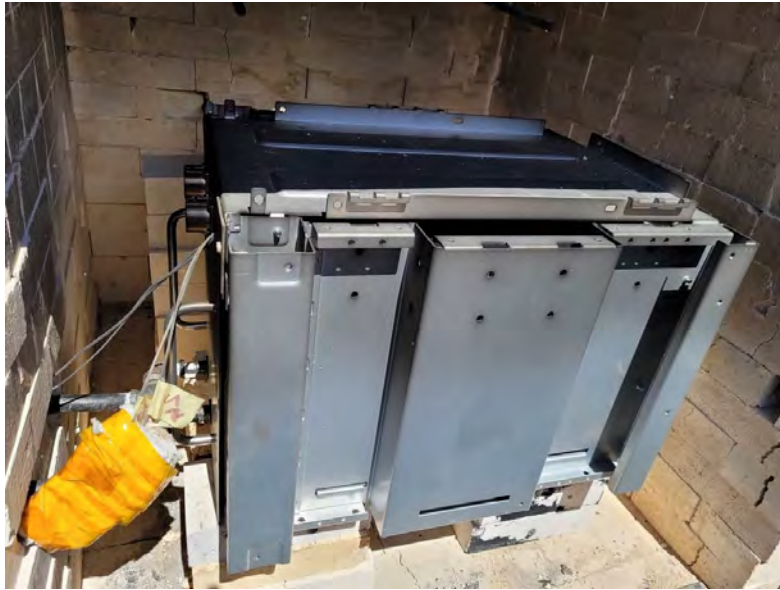
**Picture 7 – Unit BBU – Unit After Exposure at 215°C**

No safety issues or damage to the cooling system was observed at conclusion of test.

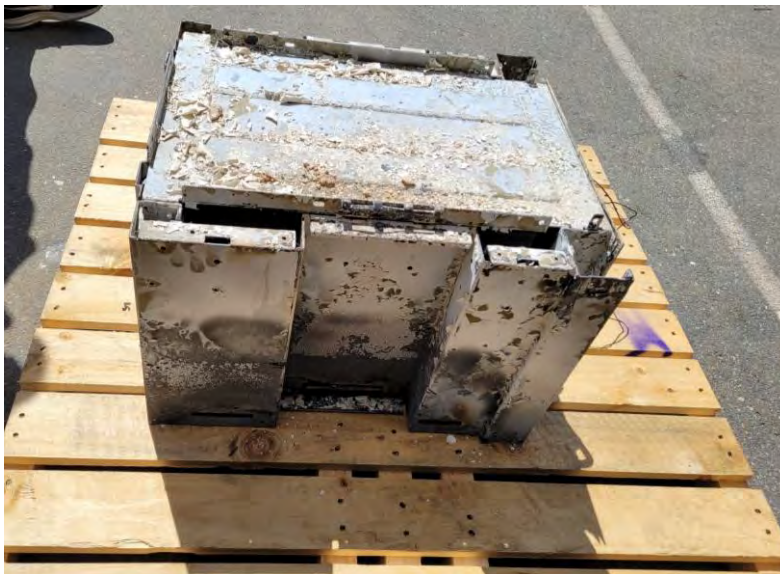
**Picture 8 – Unit BBU – Unit After Exposure at 950°C**

Battery largely intact although almost all plastics melted and consumed, as expected. Insulation sheets applied to top and ends also intact but damaged at edges due to melting of the sealing tape used. None of the insulation had burned. The two cooling cap brackets came off easily with no evidence of heat warping. Cooling caps themselves and the seals beneath were all in excellent condition. The compression bars were in very good condition, as were the plastic isolation bars – only the end bars (#1 and #25) has heat damage on their respective external sides. There was only minor heat damage observed on cells #1 and #24 without affecting their integrity or voltage – all other 22 cells were in almost pristine condition. All cells still had a serviceable voltage, just below the charged voltage when the battery was constructed for testing, allowing for about 5 days relaxation.

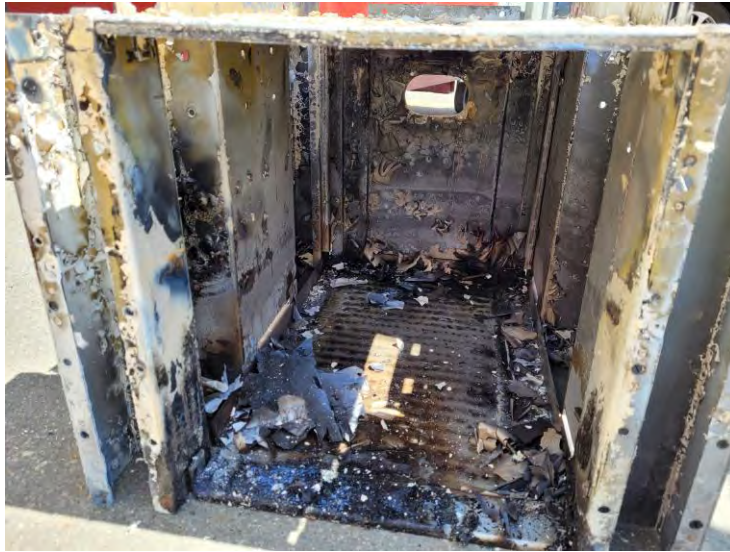
**Picture 9 – Unit BBU – Unit After Exposure at 950°C – Rack Internal View**

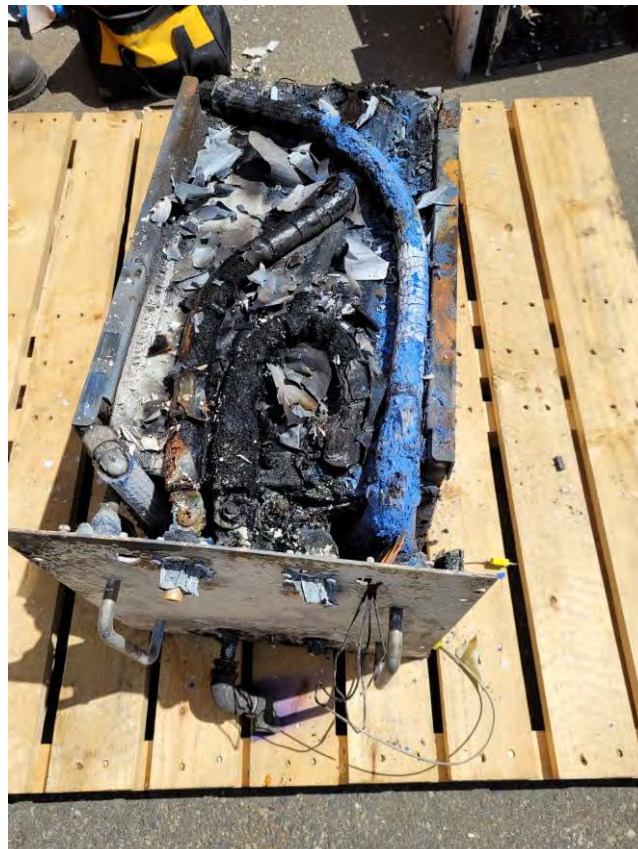
**Picture 10 – Unit BBU – Unit After Exposure at 950°C – Battery Only – Top View**

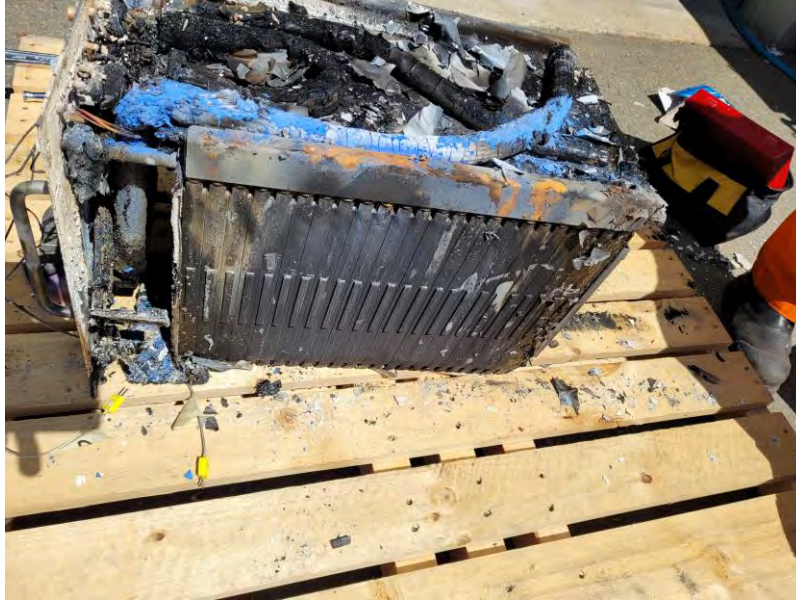
**Picture 11 – Unit BBU – Unit After Exposure at 950°C – Battery Only – Side View**

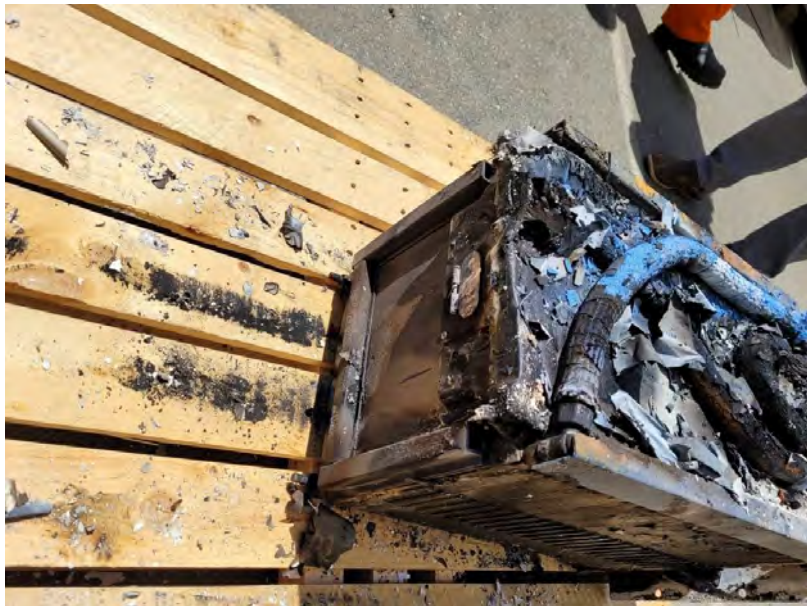
**Picture 12 – Unit BBU – Unit After Exposure at 950°C – Battery Only – Back View**

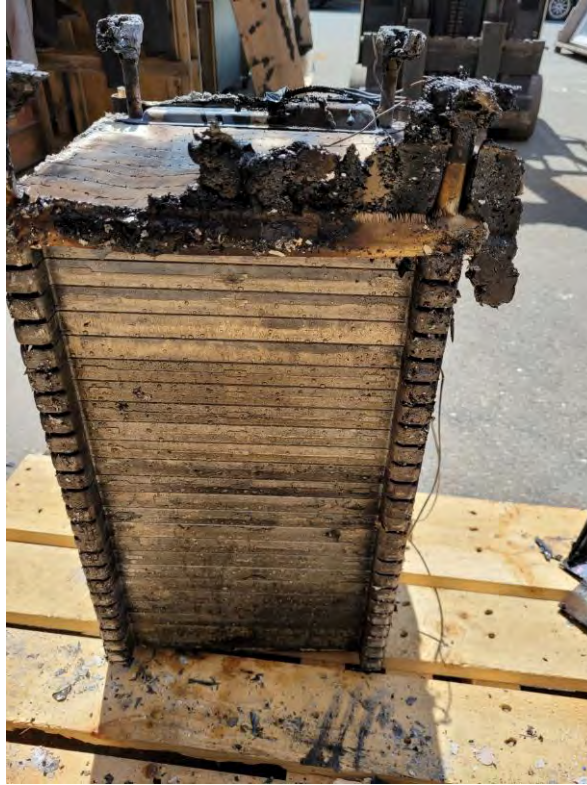
**Picture 13 – Unit BBU – Unit After Exposure at 950°C – Battery Only – Bottom View**

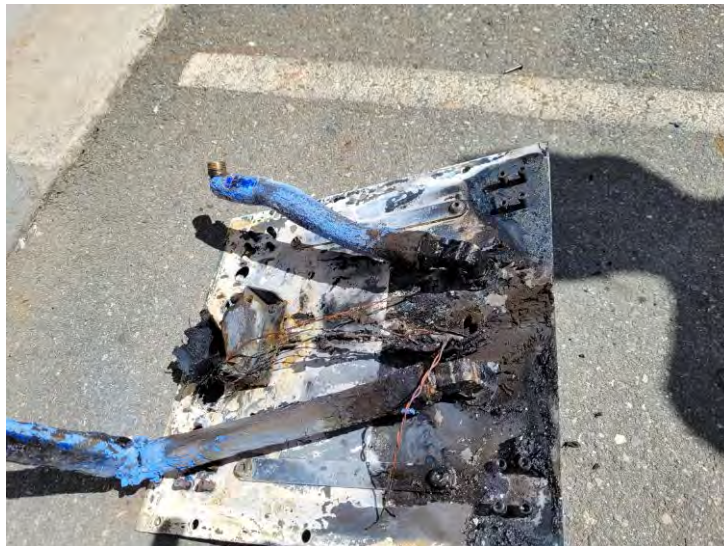
**Picture 14 – Unit BBU – Unit After Exposure at 950°C – Front Panel Removed**

- Battery removed from heat chamber
- Battery module removed from rack
- Two internal cooling hoses disconnected from cell carriers
- Face plate removed – pulled off of the cell stack as the upper isolation blocks had melted and lower blocks were partially attached
- Water drained from cell stack – stack was rested on its front to allow the water to escape
- Two cooling cap brackets removed
- All cooling caps removed
- Top plate removed
- Compression bars removed
- Stand up all cell tabs
- End plate removed
- Cell carriers removed one at a time, with cell voltages recorded and cell condition noted

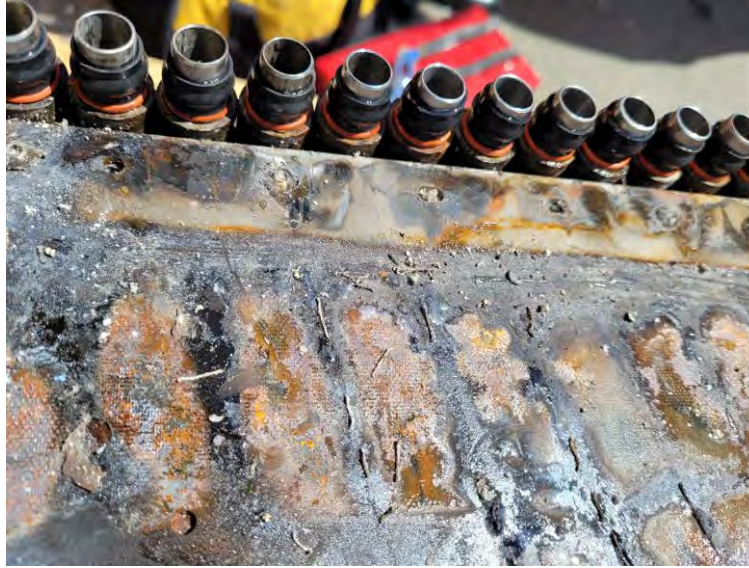
**Picture 15 – Unit BBU – Unit After Exposure at 950°C – Water Coolant System Caps Removed – View of Gaskets**

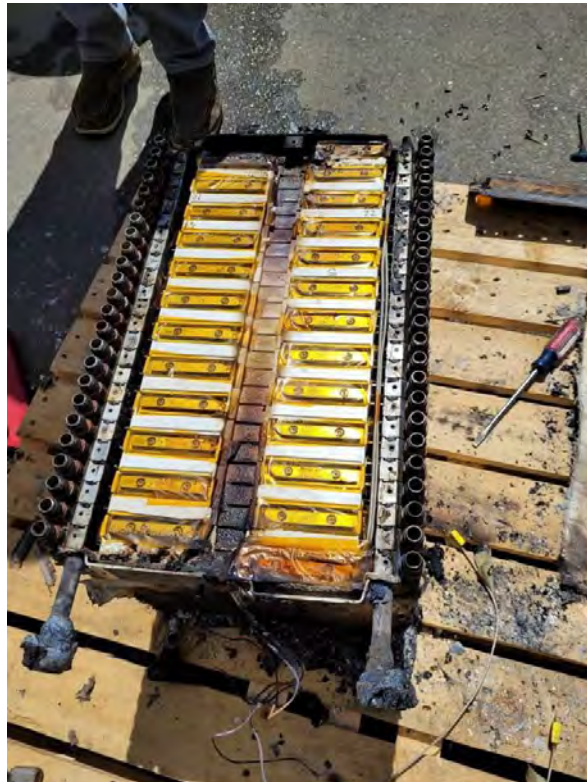
**Picture 16 – Unit BBU – Unit After Exposure at 950°C – Top Protection Panel Removed – Exposed Battery Top Cells**

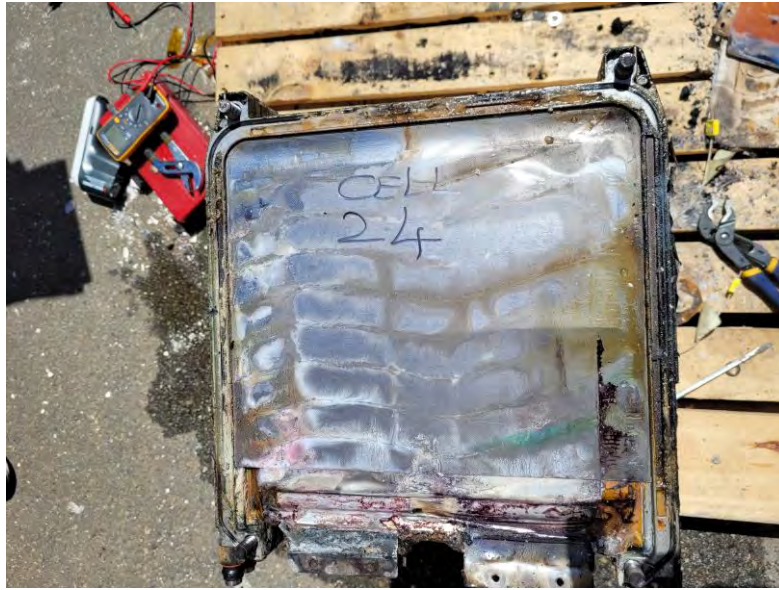
**Picture 17 – Unit BBU – Unit After Exposure at 950°C – Back Protection Panel and Insulation Removed – Cell No.24 View**

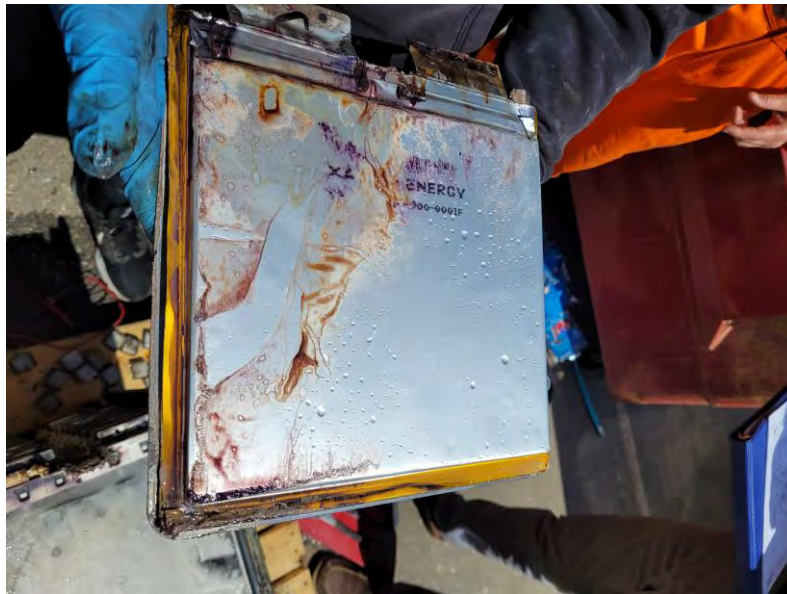
**Picture 18 – Unit BBU – Unit After Exposure at 950°C – Back Protection Panel and Insulation Removed – Cell No.24 Back View**

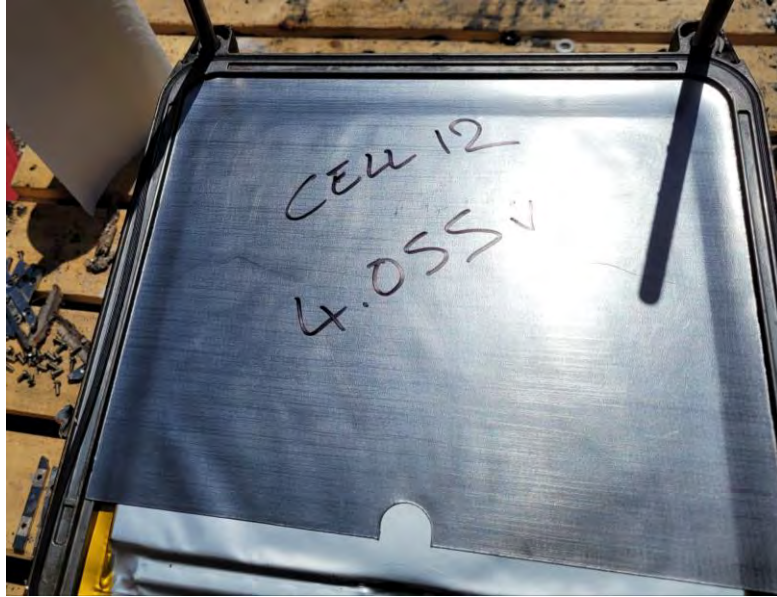
Picture 19 – Unit BBU – Unit After Exposure at 950°C – Cell No.12 View

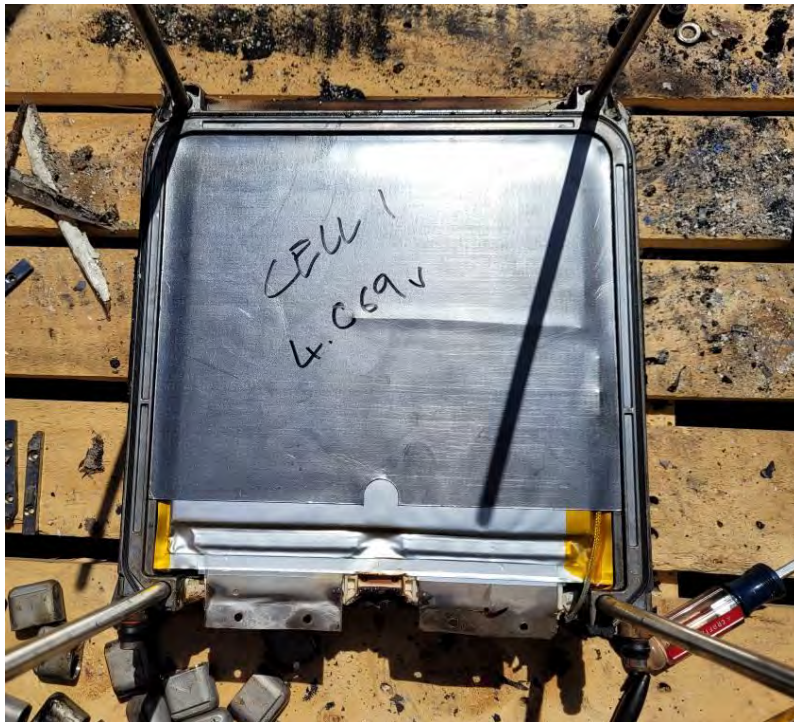
Picture 20 – Unit BBU – Unit After Exposure at 950°C – Cell No.1 View

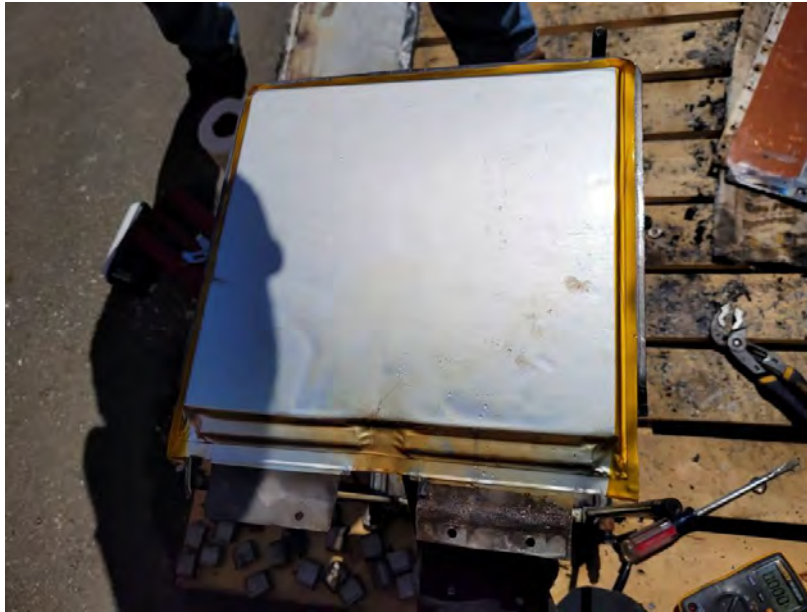
**Picture 21 – Unit BBU – Unit After Exposure at 950°C – Cell No.1 Exposed Side View**

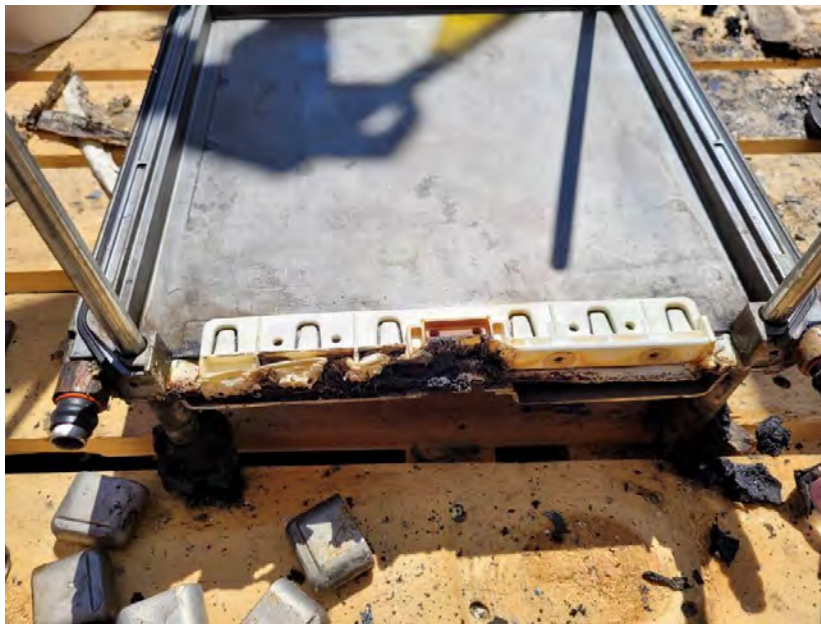
**Picture 22 – Unit BBU – Unit After Exposure at 950°C – Front Panel Isolation Block Condition and Close-up of Gas Gasket**

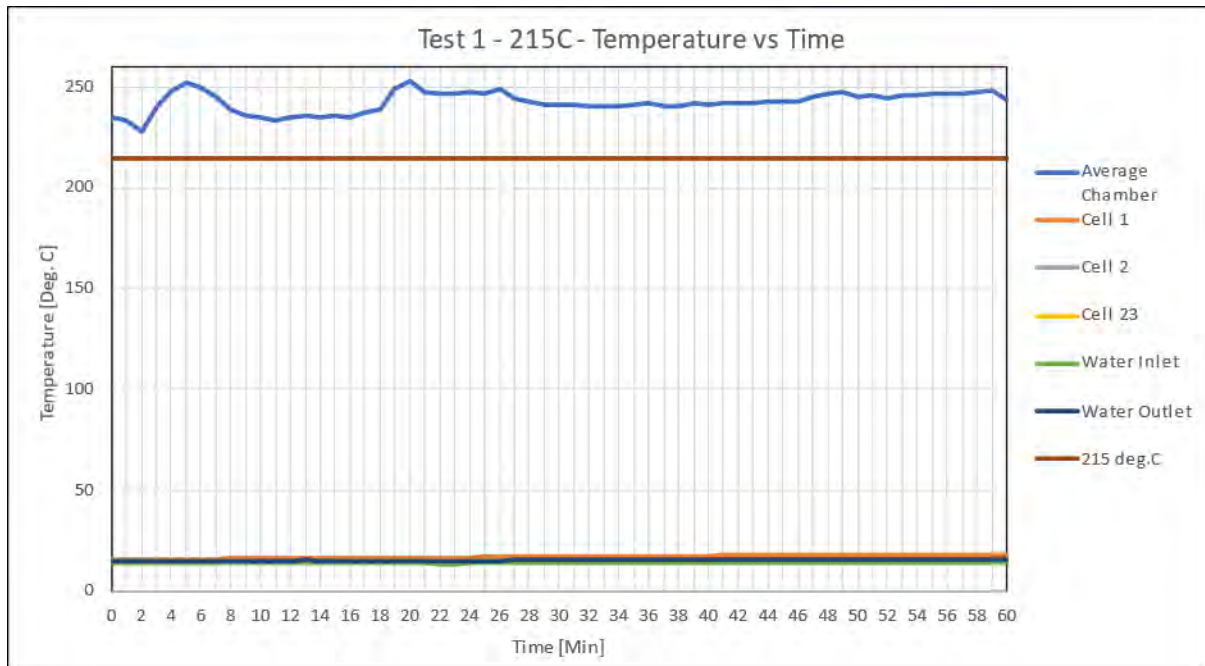
**215°C Test Temperature Graph**

The Testing chamber was heated up just over 215°C and maintained for 1 hour to verify that the BBU cooling system can keep the cell temperature below 150°C for 60 minutes.

The average test chamber temperature during the 60 minute period was 242.58°C

The cooling system was supplied water at ambient temperature at a minimum of 8 litres/min.

<b>215°C Temperature Test</b>						
	<b>Cell 1</b>	<b>Cell 2</b>	<b>Cell 23</b>	<b>Cell 24</b>	<b>Water in</b>	<b>Water out</b>
<b>Maximum temperature measured (°C)</b>	17.99°C	15.77°C	15.64°C	N/A	13.97°C	15.55°C
<b>Safety Issues (fire, smoke)</b>	No					
<b>Damage to cooling system (leakage)</b>	No

**Note:** Cell 24 temperature could not be recorded due to a fault in the thermocouple.

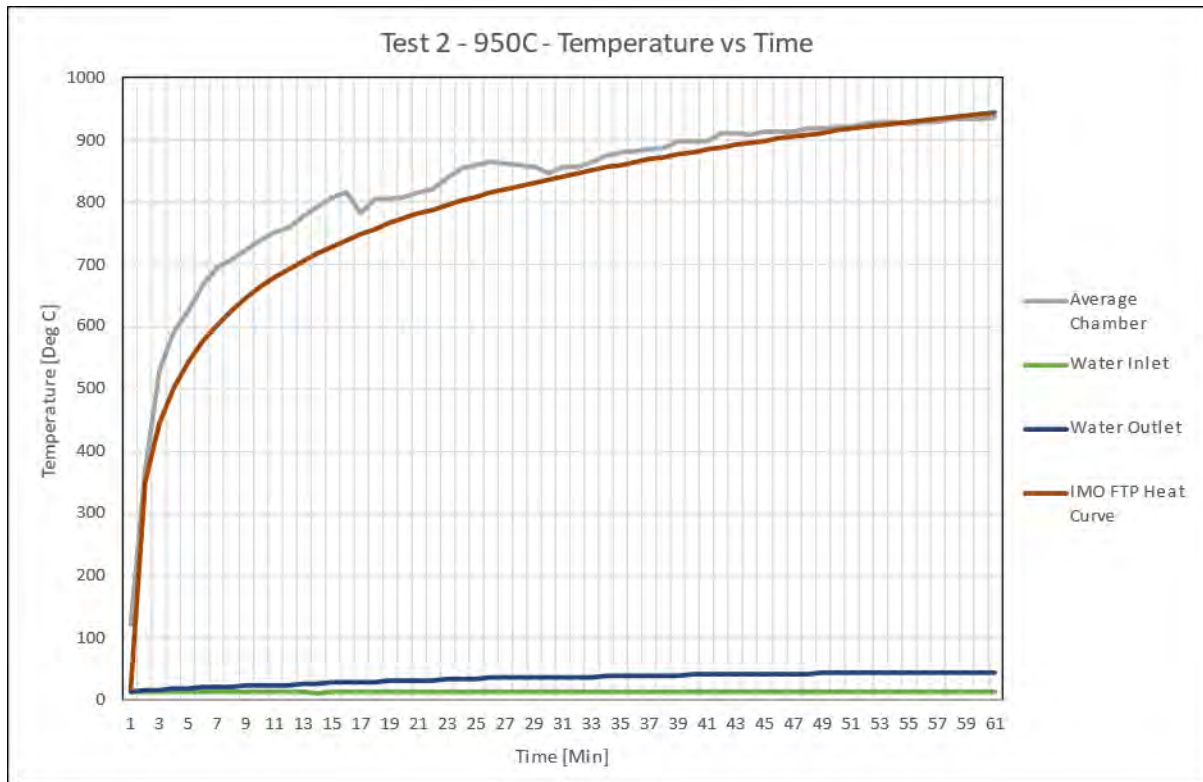
**950°C Test Temperature Graph**

The Testing Chamber was set to heat up to 950°C and intended to be maintained for 1 hour to verify that the BBU cooling system can keep the cell temperature below 150°C for 60 minutes and the cooling systems is not damaged.

The 950C test furnace heating followed the IMO FTP Code temperature curve,  $T=345\log_{10}(8t+1)+20$ , as seen in the figure below, to a maximum of 945°C at 60 minutes test duration. The actual maximum heat chamber temperature reached during the test was 937°C.

950°C Temperature Test						
	Cell 1	Cell 2	Cell 23	Cell 24	Water in	Water out
Maximum temperature measured (°C)	N/A	N/A	N/A	N/A	14.08°C	47.78°C
Safety Issues (fire, smoke)	No					
Damage to cooling system (leakage)	No

**Note:** Cell temperatures could not be recorded due to faults with the thermocouples.
